Chapter 17

Archaeological investigation of the Robert Portner Brewing Company site

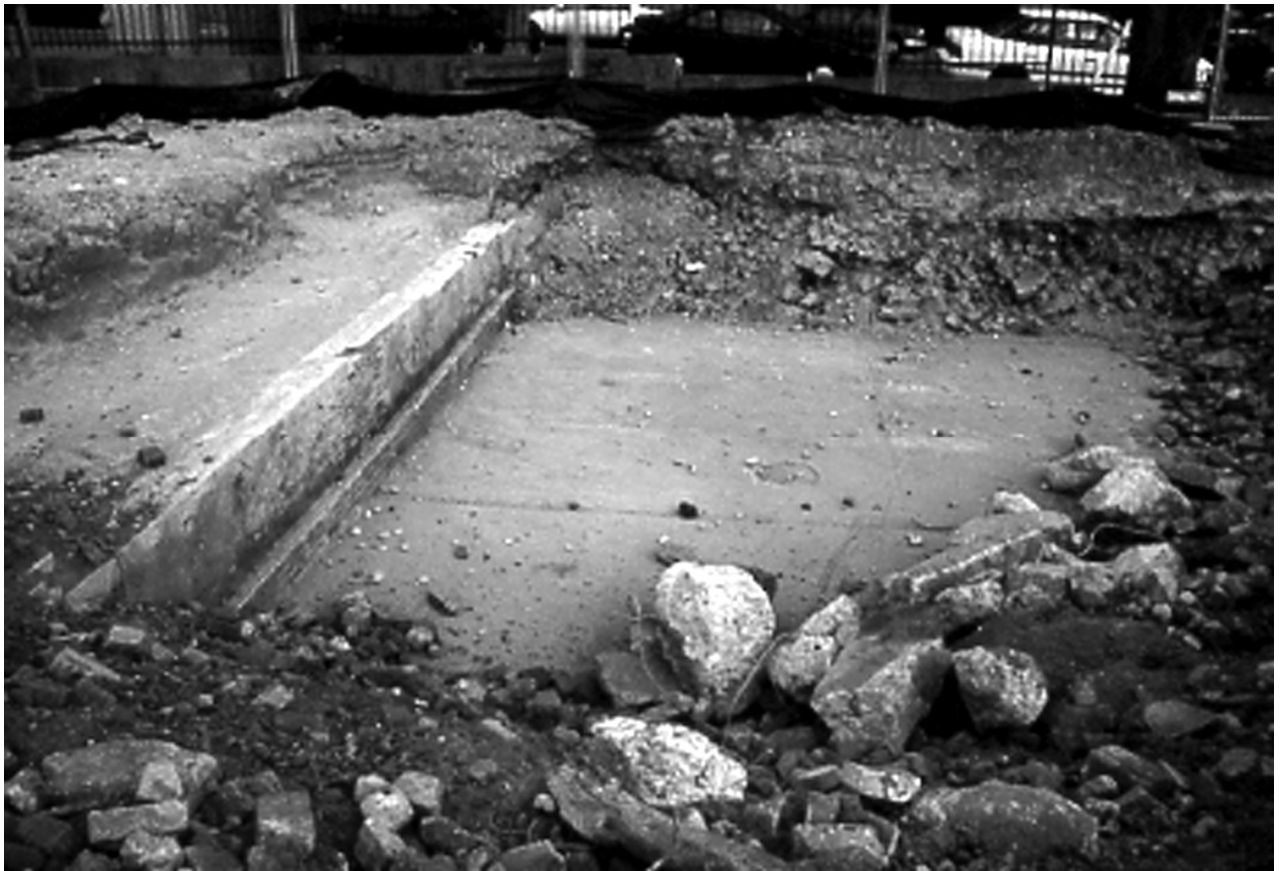
A portion of the lager cellar floor uncovered. Alexandria Archaeology photograph.

After much searching, the perfectly preserved floor of the beer cellar was uncovered at the southwest corner of Saint Asaph and Pendleton Streets. The northernmost section of the plant, the exposed portion measured nearly 40 by 50 feet, although some of Portner's vaults may have reached 70 feet in length, but narrower.¹ This would have been the location for the fermentation and aging of much of the beer produced by the brewery in the 1880s. The concrete floor was bisected by a gutter running west to east and dropping about a foot over its course. The gutter obviously served to drain off ice melt as well as wash water and spilled beer. Immediately to the north of the gutter were the remnants of footers for a line of four vanished cast-iron columns that once supported the ground floor above. The columns were probably of identical heights; the footers grew taller as they went east, accounting for the slope in the floor. The truncated section of the cellar's western brick wall held pairs of cut spikes at two-foot intervals, nailed across each other and into the mortar joints. With tiny bits of wood still attached, they apparently held vertical scantling that would have served as furring strips for horizontal wood paneling along that section of wall.

The most remarkable aspect of the cellar was the marks left in its floor. Apparently, great weights set upon the concrete surface left a permanent series of shallow, rectangular depressions in regular rows. Each was perhaps four and a half feet long and a foot wide, at four-foot intervals

from the other similar and parallel depressions. Oriented east-west, these depressions appear to have been left by the immense loads upon timber stillions or stands that once supported the large aging casks. Extrapolating from the depressions that were actually exposed, it appears that there were once four parallel rows of five casks each in the cellar.² Given the size and spacing of the depressions, the casks might have held well over 100 barrels of beer each. A concrete of Portland or similar cement would suggest a date for the floor consistent with the late nineteenth century. At that time, above-ground, artificially cooled spaces were increasingly employed.
